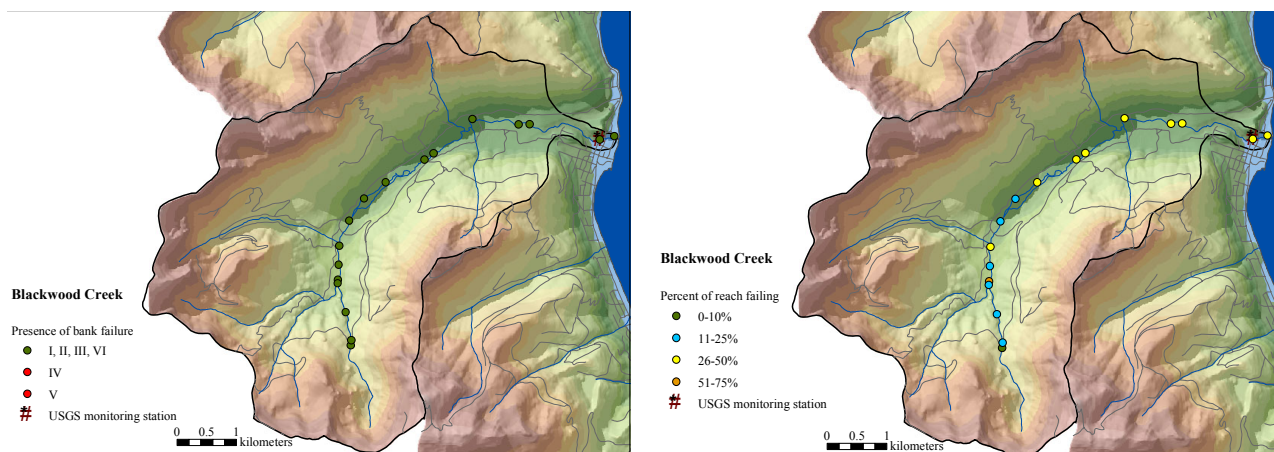
Figure 4-25. Presence or absence of bank failures and the percent of the longitudinal extent of left and right banks undergoing active mass-wasting processes along Blackwood Creek.
